CONCRETE REPAIR BULLETIN

TRENCHLESS EMERGENCY REPAIR OF MILE-LONG PENSTOCK WITH FRP

BY MO EHSANI AND CARLOS PEÑA

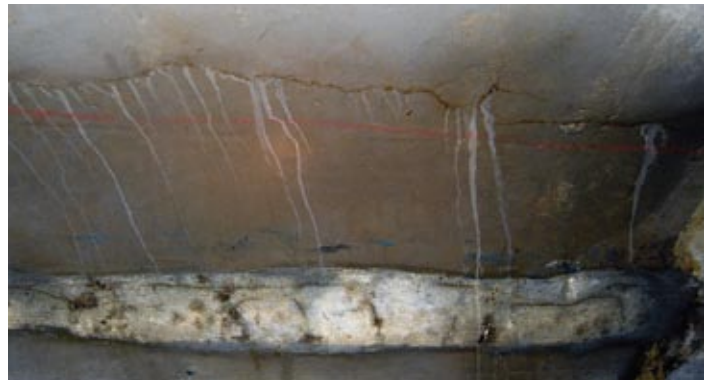
Fig. 3: Water seeping into pipeline

the constant tropical rains. Because most of the pipeline is buried underground, water draining down the mountains keeps the surrounding soil constantly saturated, which generates seepage pressures. In fact, with the pipeline empty, seepage water was observed draining through some of the longitudinal cracks (Fig. 3).

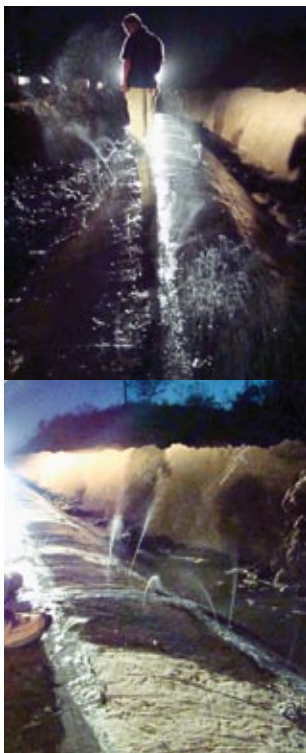
The pipeline was drained and all visible cracks were sealed using typical repair materials. When the pipeline was pressurized for a second time, the repaired cracks leaked again. The leaking

at the repaired cracks was most likely due to the increase in the crack width due to the deformations of the pipeline caused by the increase in internal pressure. Given the relative rigidity of most crack sealing materials, full deformation compatibility between the repair material and the surrounding concrete could not be achieved, degrading the integrity of the seal and allowing leaks to reoccur. Figure 2 illustrates typical leaks occurring along the length of the pipeline during tests conducted at maximum operational pressure.

Fig. 2: Leaking after conventional crack sealing

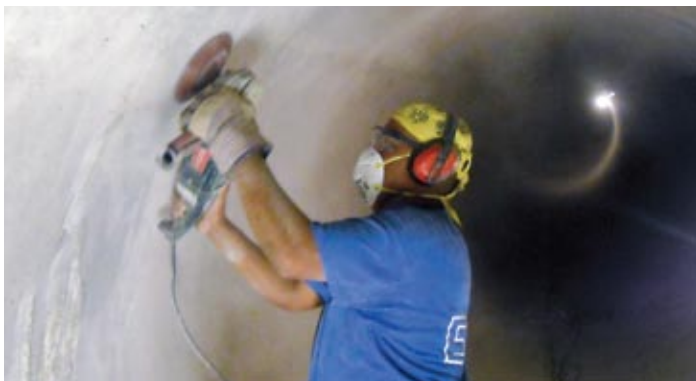
Fig. 4: Preparation work prior to installation of FRP lining

The application of FRP linings requires a certain amount of preliminary work to the pipe surface to maximize contact and bond strength between the substrate and the FRP. Therefore, pressure washing and/or sandblasting, as well as some patching and/or grinding, must take place in the areas targeted for lining with FRP. In the case of the El Encanto pipeline, the amount of surface prep work was atypically large because the cast-in-place construction process caused significantly more surface irregularities than those associated with the more traditional precast pipes, such as prestressed concrete cylinder pipe (PCCP). Evidence of cast-in-place procedures such as construction joints and formwork fins was visible in the pipeline. The pipeline was pressure washed with 7000 psi (48.3 MPa) machines to remove any scour, sediment, curing compounds, and any other substance that could hinder the bond between the FRP and the pipe surface. Figure 4 shows grinding of protrusions on the interior surface of the pipeline.

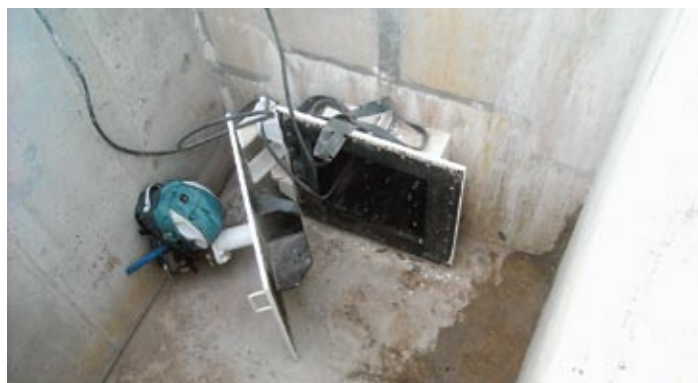
The 5742 ft (1750 m) long penstock had four lateral access points at the locations of relief valves, with spacing ranging from 1000 to 1500 ft (305 to 457 m). These 24 x 24 in. (810 x 610 mm) access points were used by the crew to supply FRP materials, tools, and equipment to four installation stations inside the pipeline. (Fig. 5)

Fig. 5: Typical 2 ft. x 2 ft. access point

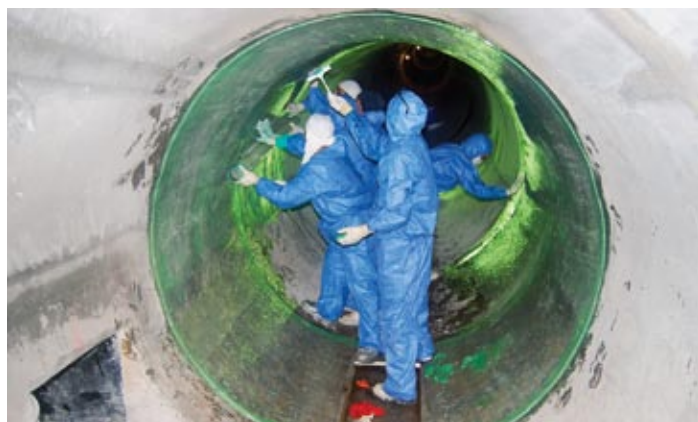
Fig. 6: Installation of FRP sheets on the interior surface of the pipeline

An epoxy paste was applied to the top half of the pipeline; the main purpose of the paste is to prevent peeling due to self weight of the saturated FRP fabric and to seal the surface to prevent excessive absorption by the dry concrete surface of the epoxy resin from the saturated FRP fabric. Figure 6 shows the installation of the first roll of FRP lining material at one of the installation stations. The access point is clearly visible on the lower left portion of the figure. No epoxy paste was used in the lower half of the pipe. Because gravity forces in this area tend to hold the FRP fabric in place, only a seal coat of epoxy resin was used to prevent excessive absorption by the dry concrete surface of epoxy resin from the saturated fabric. The edges of the 50 in. (1270 mm) wide bands of fabric were adequately overlapped in the hoop and longitudinal directions to

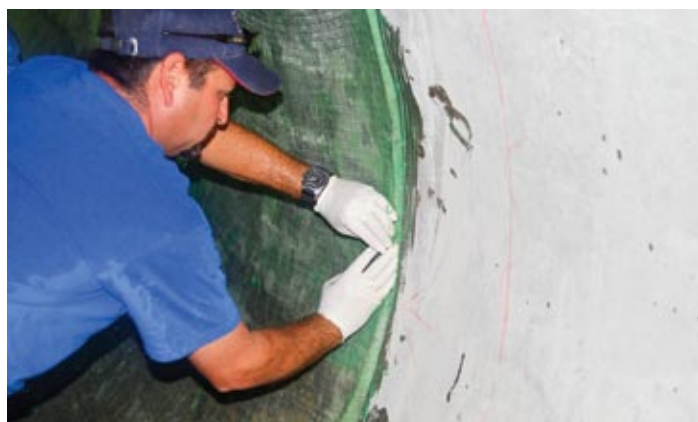
Fig. 7: Construction joint of FRP lining

Specially designed construction joints were prepared at the starting point of each installation run, which also became the end points of the installation front that started at a downstream access point. The joint was later sealed with an epoxy paste (Fig. 7). Nowhere in the 5742 ft (1750 m) length of the pipeline were FRP lining edges left exposed to peeling from water flow, maximizing the water tightness of the installation.
