Restoration of Large Diameter Prestressed Concrete Cylinder Pipelines

Water Flow, New Mexico
Submitted by QuakeWrap, Inc.

San Juan Generating Station, New Mexico

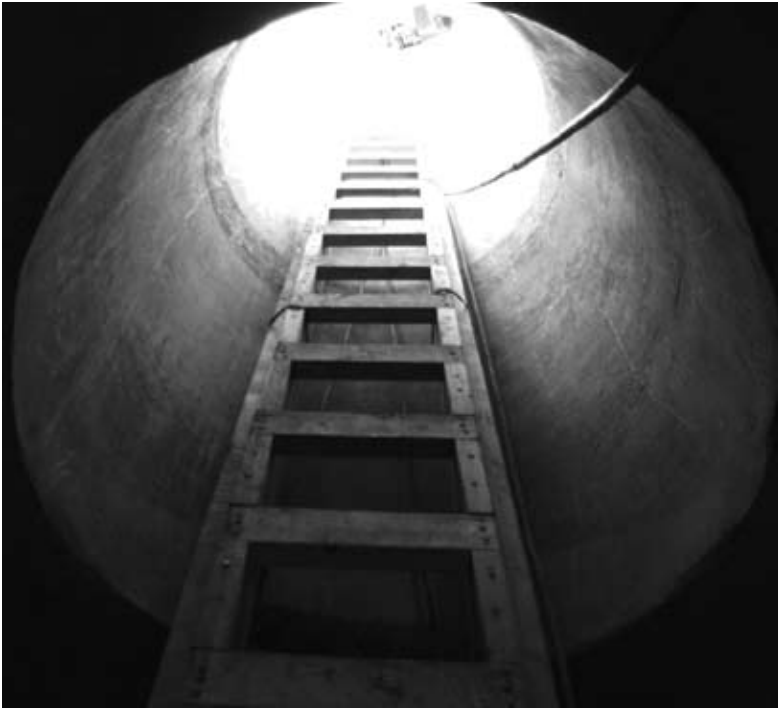
The only access to pipe was through 30 in. (760 mm) diameter manholes

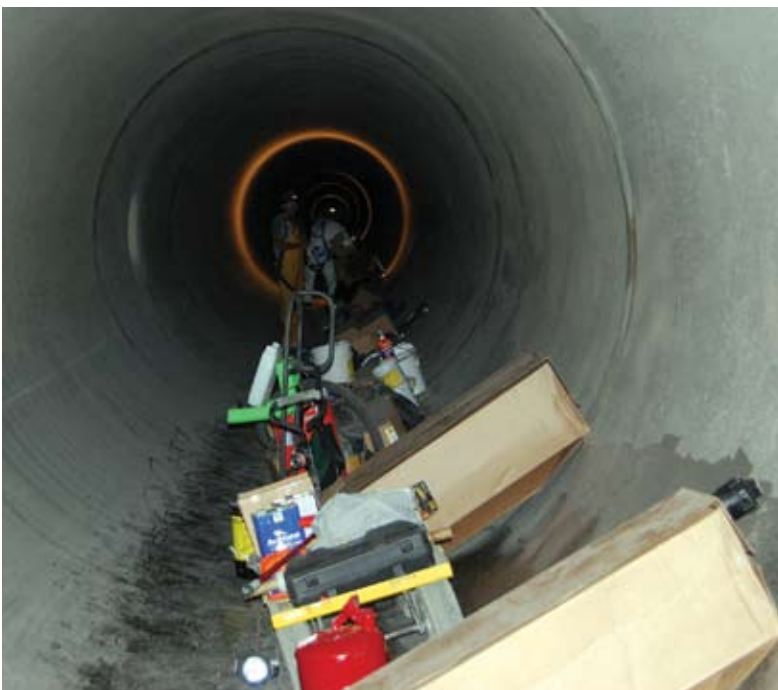
Materials were spaced out throughout the 840 ft (256 m) long section of pipe

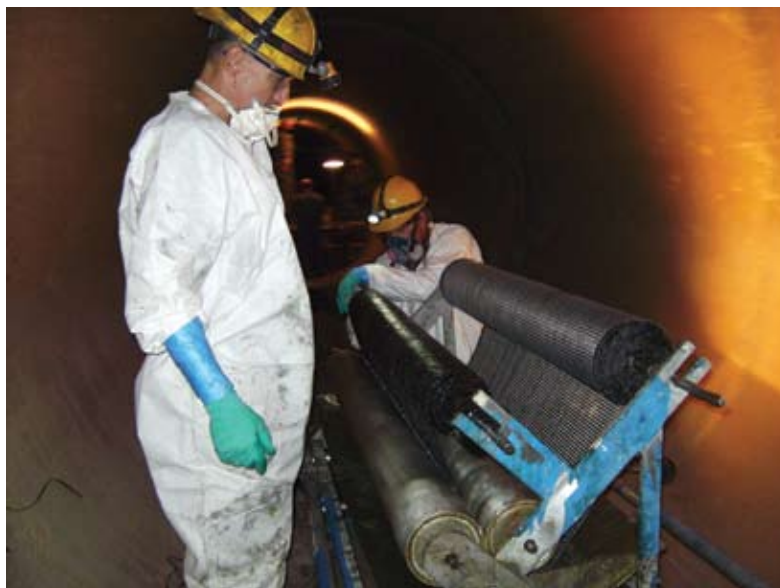
Saturating machine reassembled inside the pipe

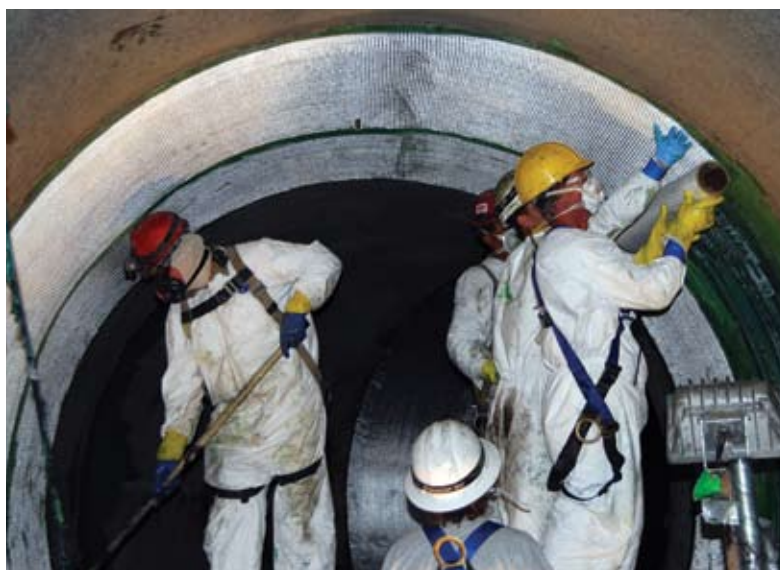
Installation of glass fabric on pipe

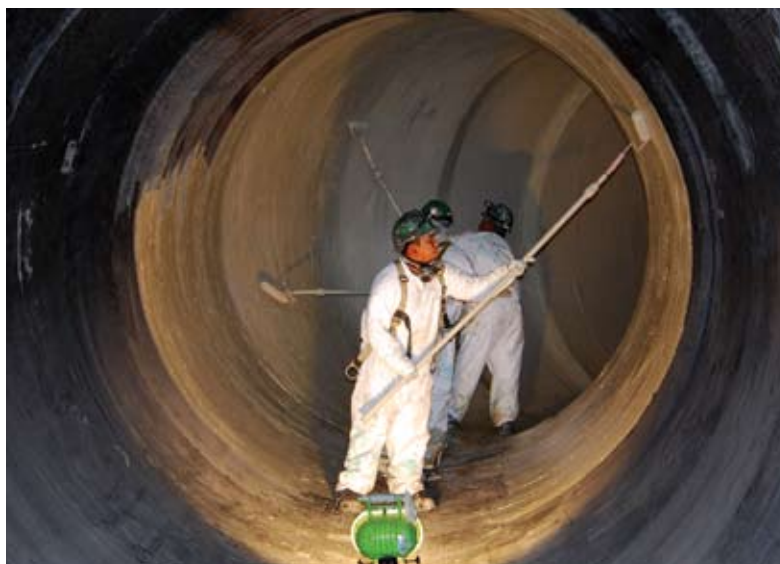
Application of final finish coating over installed FRP

A final top coating of epoxy was applied for improved abrasion resistance and to minimize friction losses. Because the shutdown units could not be placed back into service without flooding the PCCP pipes, the CFRP liner had to be installed and fully cured within a 4-week period to avoid service delays. Therefore, the CFRP liner installation was in the critical path of the maintenance program. Even with the complex geometries encountered, the liner was installed in a 3-week period—1 week ahead of schedule.
