Restoration of Large Diameter Prestressed Concrete Cylinder Pipelines

Water Flow, New Mexico
Submitted by QuakeWrap, Inc.

San Juan Generating Station, New Mexico

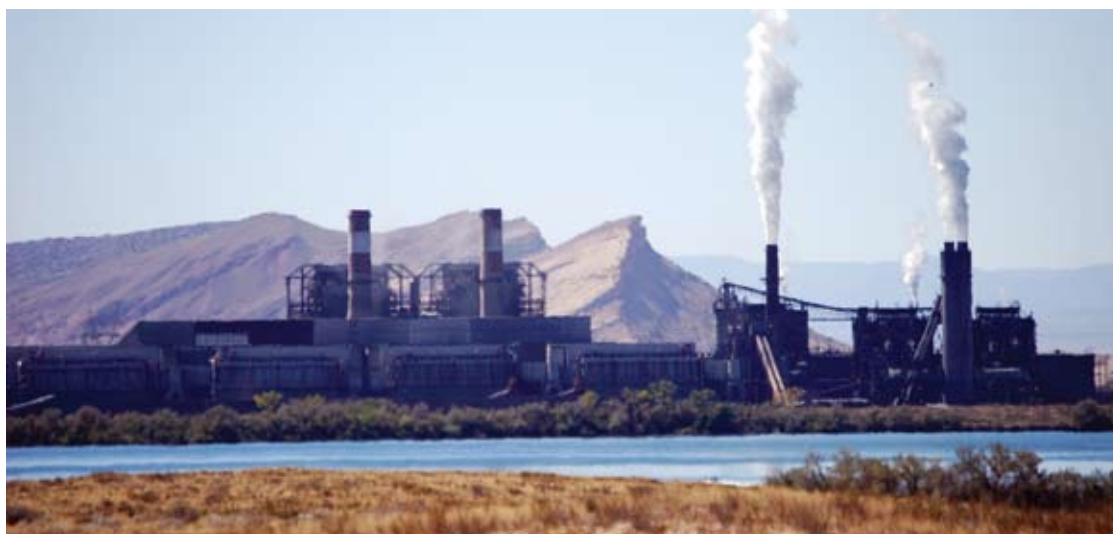
These pipes have a minimum 35-year service record and have begun to experience serious

concrete, initiating the corrosion process. If the corrosion process is not mitigated, enough steel will be lost that the structural integrity of the PCCP will be compromised.

During maintenance shutdown periods, the PCCP is dried up and the integrity of the pipe is evaluated using sophisticated equipment that can detect hidden corrosion. Based on the degree of corrosion, 840 linear ft (256 m) of PCCP was targeted for urgent repair at the San Juan Generating Station.

Surface preparation consisted of sandblasting the inside of the PCCP to remove sediments, patching visible cracks and spalling, and smoothing (with grinders and patches) PCCP connections. Once prep work was completed, the CFRP installation scaffolding system, CFRP saturating machine, as well as all the epoxy resin buckets and CFRP fabric rolls, were lowered through the 30 in. (760 mm) diameter manholes. This required the redesign and fabrication of new equipment that could be disassembled, passed through the relatively narrow access, and reassembled inside the PCCP.

about 2 weeks. Complex geometric transitions were encountered, however, such as an elbow turn of the 10 ft (3 m) diameter PCCP, as well as steel jacket transitions. The tight elbow section space did not allow for the use of the scaffolding system; and to avoid excessive overlaps and potentially large blisters and wrinkles in the liner, the CFRP strips were cut in variable width strips, following the complex tridimensional geometry of the elbow closely. Steel jacket segments were present in the PCCP due to previous repairs. Because a galvanic corrosion barrier is required between carbon and steel, a glass FRP (GFRP) fabric liner was placed over the jacket before installing the CFRP liner. Also, because the steel jackets were welded in place using individual plates, significant amounts of patching compound had to be used to smooth out the joints.
