STIFPIPE REPAIR OF 24" CORRUGATED METAL PIPE CULVERT

Name: 24" Corrugated Metal Pipe (Culvert)
Type: Pipe Repair
Location: Mobile, AL
Completed: November 2012

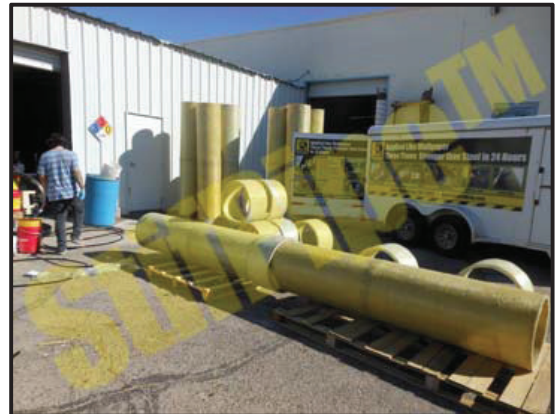
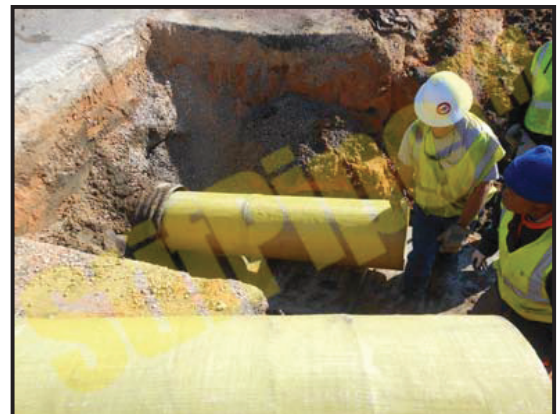
This 24" corrugated metal pipe (CMP) culvert ran under a main roadway just outside downtown Mobile, Alabama. The internal lining of the pipe had deteriorated so much it was virtually nonexistent. The pipe itself was also suffering from major rust and corrosion.

Once the pipe was cleaned and the previous liner completely removed, eight 8-ft long X 18-inch ID pieces of StifPipe were pieced together with couplings and slid easily down the pipe. The lightweight StifPipe™ did not require any equipment and was pushed by hand. A grout was then pumped in to fill the annular space between the StifPipe™ and the host pipe. This whole process took 1 day to complete, and water was able to begin flowing freely once the grout had cured.

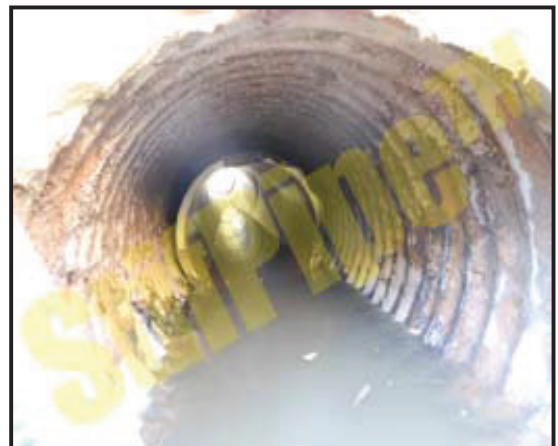
- StifPipe™ light weight allowed for the pipe to be easily pushed in just by manpower.
- Installation was completed while the roadway remained in operation.
- The StifPipe™ was made with two layers of QuakeWrap® VB26 fabric internally and externally, surrounding a honeycomb core.
